ECONOMIC SOIL REINFORCEMENT AND DRAINAGE SYSTEM TO STABILISE SLOPES IN LOOSE SATURATED SOIL

Stephen Thomas *OGI Groundwater Specialists, Durham, UK* stephen.thomas@ogi.co.uk

George French *OGI Groundwater Specialists, Durham, UK* george.french@ogi.co.uk

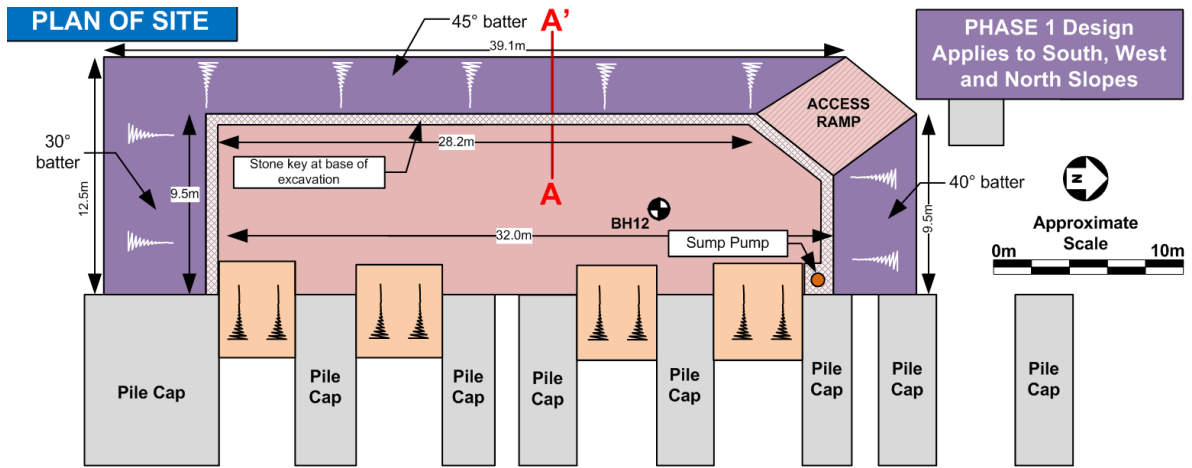
Figure 1. Site plan showing layout of the temporary excavation

One side of the excavation had exposed vertical piles, with pile caps constructed above. On three sides of the excavation, the slopes were battered at slope angles varying between 30°- 45° (Figure 1) and displayed soil instability. During an initial site visit, water ingress was observed seeping through the sides of the excavation, together with progressive slope failure in the form of running sand (Figure 2).

The pipeline excavation had previously been constructed using battered slopes by a previous contractor. To the west, south and northern sides of the excavation, there were slopes which were calculated to be in the range of 30° to 45°.

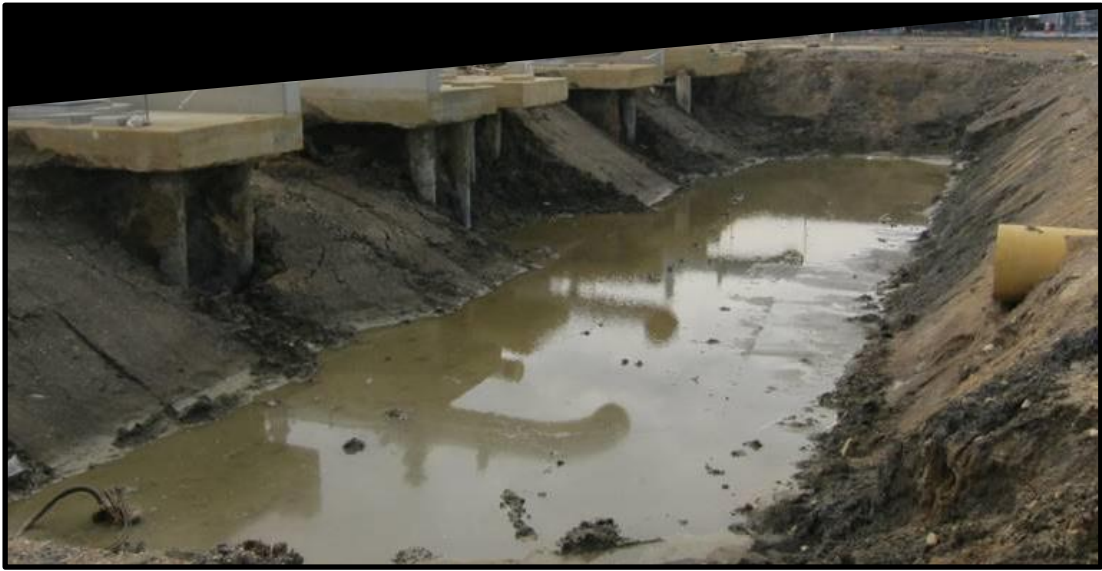
Figure 2. Excavation with soil erosion and unstable sloping sides

However, as a consequence of the high water-table, and steep slope angle, under drained soil conditions, the combination of the low drained shear strength and high groundwater seepage face resulted in local instability and running sand (Figure 2).

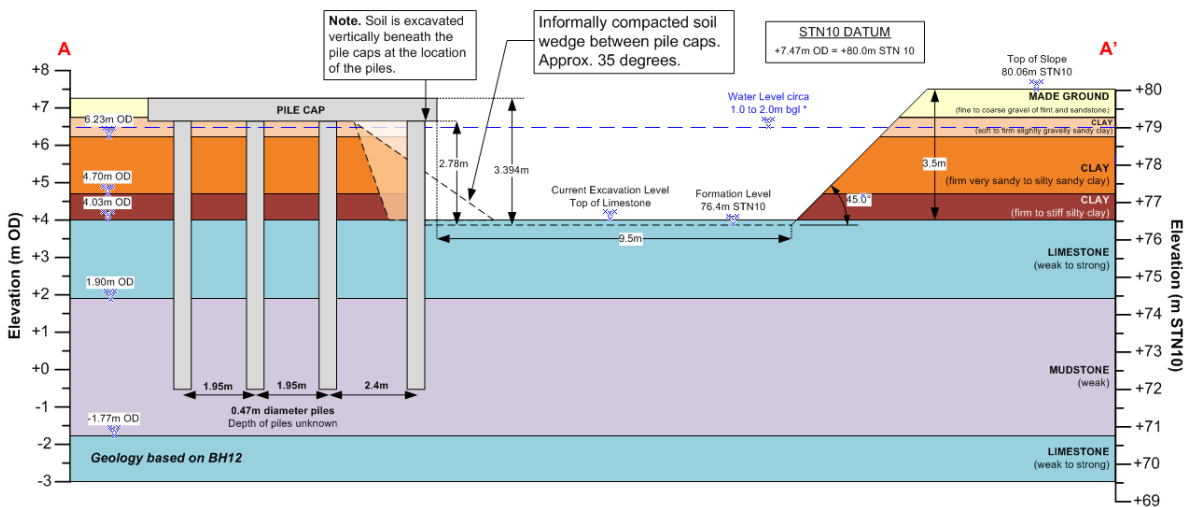
Figure 3. Conceptual model including the general excavation geometry.

The geology on the site is characterised by predominantly superficial clay soils which overlay limestone and mudstone. The clay soils contain frequent lenses of sand and silt. The water level across the site is typically one metre below ground level. The geology with the construction detail overlaid is depicted in Figure 3. All elevations are presented relative to the site datum named STN10, where +7.47m OD = 80.0m STN10.

The geological sequence, as depicted in Figure. 3, is summarised as follows:

- **Unit 0** – MADE GROUND comprising gravel sized fragments of flint & sandstone.
- **Unit 1** – Soft to firm slightly gravelly sandy CLAY.
- **Unit 2** – Firm mottled very sandy to sandy silty CLAY.
- **Unit 3** – Firm to Stiff dark grey silty CLAY.
- **Unit 4** – Weak to strong dark grey LIMESTONE.
- **Unit 5** - Extremely weak to weak thickly laminated grey MUDSTONE.

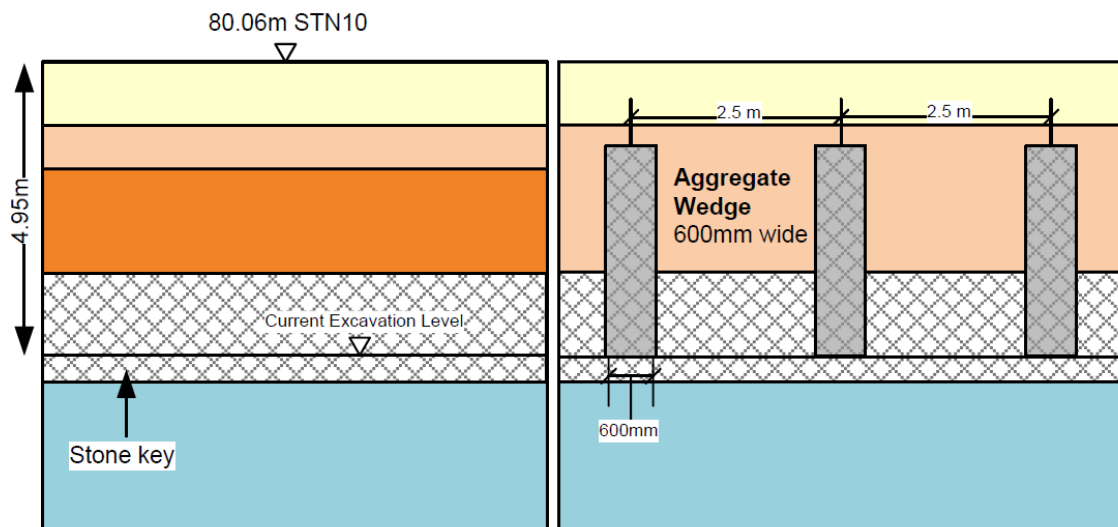
Figure 5. Cross section and inclined view of the stone key and aggregated wedges

- Sump pump residual water away from sump in the corner of the excavation.
- Install cemented aggregate wedges in the slope at spacings of 2.5m. These wedges increase friction between the soil particles and prevent circular slip failure from occurring along the long west side of the excavation (Figures 4, 5 & 10).

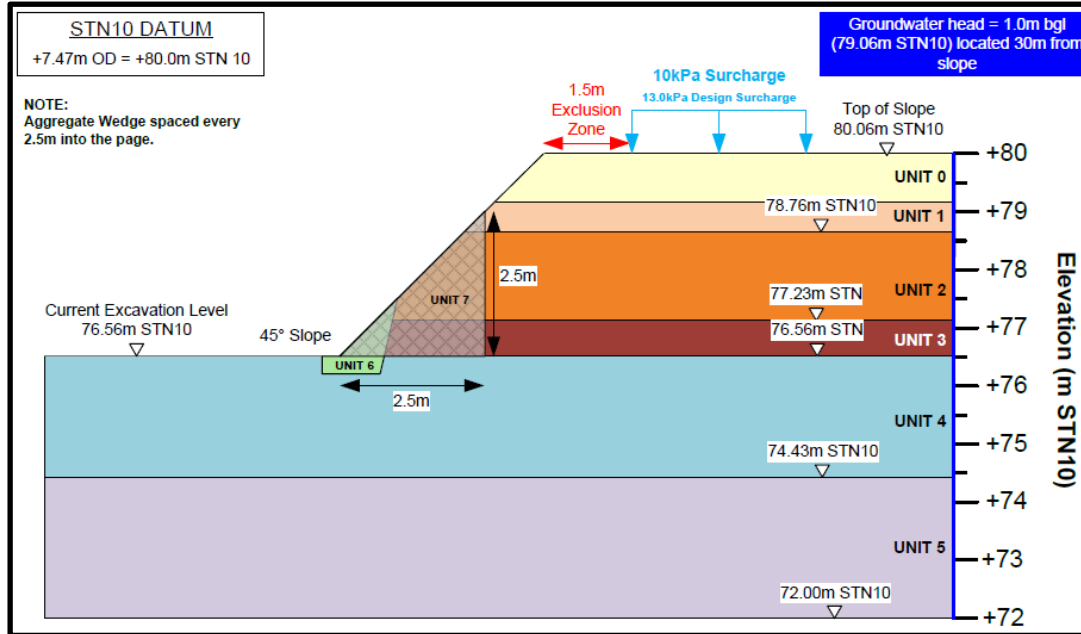
Figure 6. Conceptual model of the cemented angular stone soil reinforcement

The compacted angular stone key used MOT Type 3 (Figure 6) angular stone (Ref. 5), with the weight density (Table 5), selected using a table of typical values (Ref. 8).

The compacted angular stone key (Unit 6) was simulated as an irregular shaped horizontal strip as outlined in Figure 4. The cemented aggregate stone wedge (Unit 7) was simulated as a 600mm wide triangular structure, 2.5m deep in the centre of the model (Figure 4 & Figure 6).

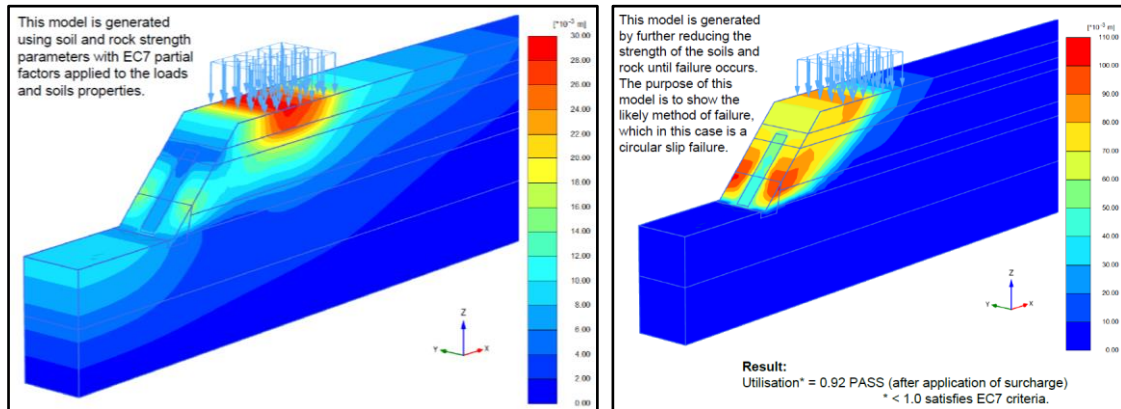
Figures 7 & Figure 8 depict the contours of simulated soil displacement (i) based on the working design loads, and (ii) when loads increased until simulated failure is reached.

Figure 7. Displacement at working design load. Figure 8. Displacement at model failure

The Plaxis 3D model evaluates the stabilizing design parameters required to produce sufficient forces to resist the destabilizing design actions just prior to model failure. The model then calculates the utilisation factor **U**, from the equation E_d / R_d where:

To demonstrate stability, Eurocode 7 requires the Utilisation, **U**, to be less than 1.0. For the parameters and partial factors described in Table 7, PLAXIS calculates **U = 0.94**

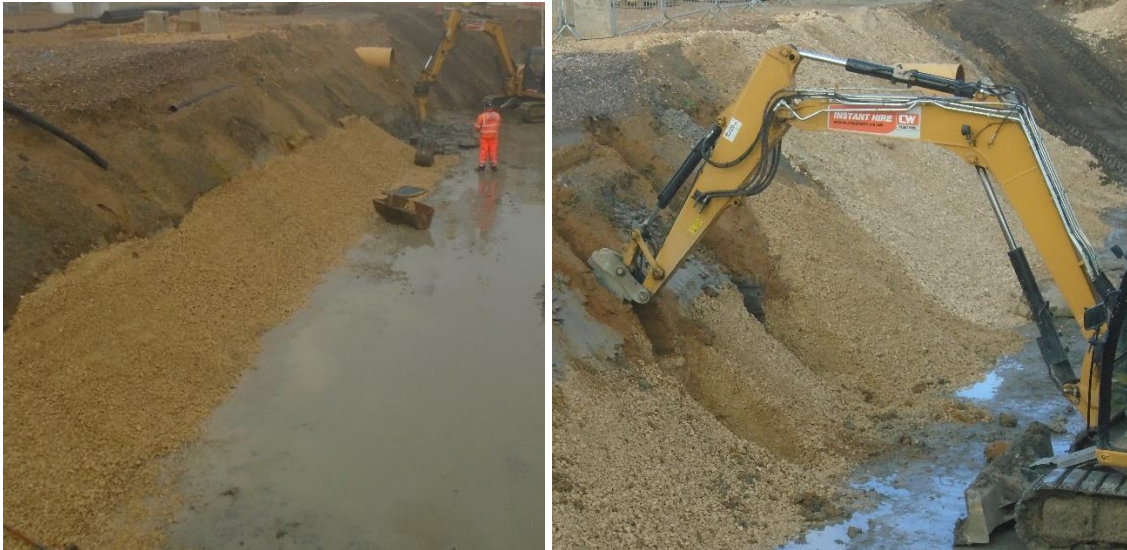
Figure 9. Construction of angular stone key. Figure. 10. Construction of aggregate wedge

- Install a stabilising angular stone key at the toe of the slope (Figures 4 & 9) so groundwater can seep out of the batter without ground loss due to loss of fines.
